Behaviour of a concrete structure in a real compartment fire

In July 2006, a full-scale compartment fire was set in an existing block of flats in Dalmarnock, Glasgow, Scotland. Prior to ignition, the structure was instrumented with deflection gauges, thermocouples and strain gauges. The growth of the fire was also carefully monitored. The resulting data provided a unique record of the behaviour of a concrete structure in fire through a heating–cooling cycle. The results show significant variation in structural temperatures within a relatively small compartment, demonstrating that the assumption of uniform temperature at any level within a fire compartment, which is implicit in many simple design fires, is incorrect. The response of the structure showed a corresponding complexity due to the combination of non-uniform spatial and temporal heating and the structural boundary conditions.

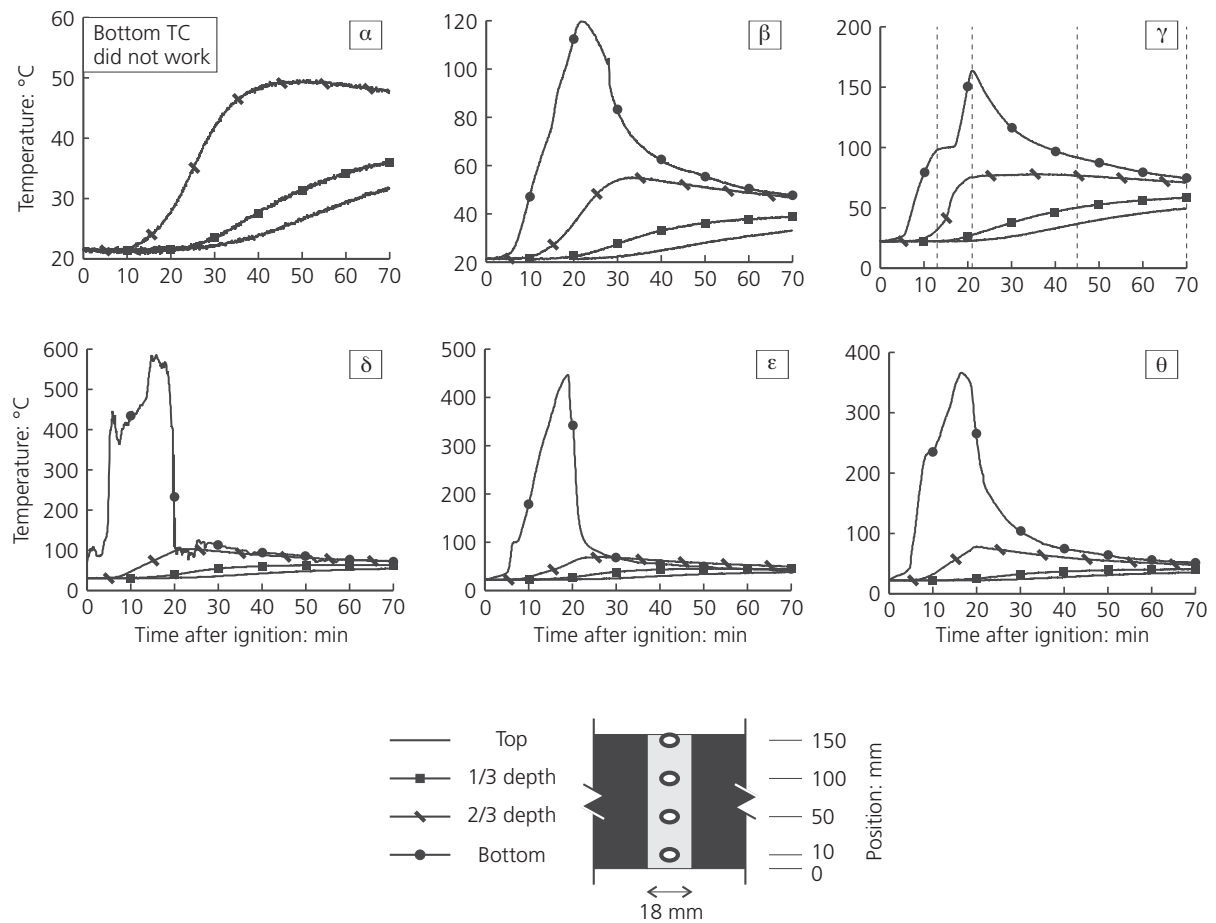
Thermocouple readings from within the ceiling slab are plotted in Figure 10, which also shows the position of the individual thermocouples through the depth of the slab at each of the locations in Figure 6. It is clear from these plots that the locations at which highest temperatures occurred within the area of the slab were very localised and that a steep thermal gradient was produced in the slab.

The highest temperatures were recorded at locations δ , ϵ and θ , away from the compartment window. This was because ventilation to the fire was initially supplied via the doorway to the hall (Figure 2). Of these three locations, δ was above the sofa and hence recorded the highest temperatures. Although θ was above the second largest fuel source (a bookcase heavily laden with combustible material), its location in the north-east corner of the room and adjacent to the cool slab in the kitchen meant that lower temperatures were recorded here than at locations δ or ϵ .

After the window of the compartment was broken, ventilation to the compartment changed, and there was an increase in the temperatures recorded at location γ . Locations α (in the south-east corner of the room) and β (near the window) remained relatively cool throughout the tests.

Figure 10. Temperature data recorded at the locations shown in Figure 6 (note the different temperature scales used at each location)

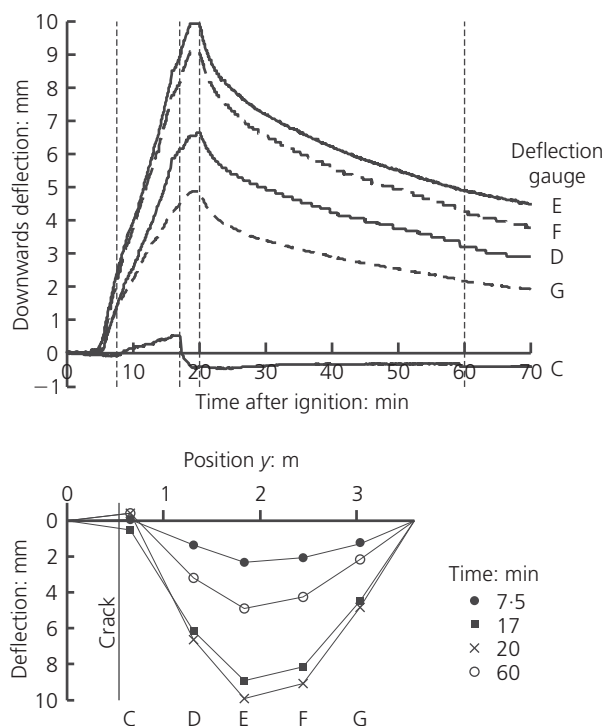
The peak deflection at the centre of the slab was around 10 mm, with 4 mm of this deflection recovered on cooling. Since the fire duration was short and high temperatures only penetrated a short distance into the concrete slab, the majority of the deflections recorded will have resulted from thermal curvature rather than from loss of material stiffness or strength. Across the north–south section (Figure 12), the deflections reduce towards the edges of the slab, as expected. It is notable that gauge C recorded negative (upward) deflections from around 18 min. This corresponds to the formation of a hogging crack in the slab that effectively moved the support from the wall to slightly inside the fire compartment. The crack formed slightly to the south of gauge C (Figure 9). As the fire cooled (Figure 8) but the upper layers of the slab continued to heat up (Figure 11), the deflection of the slab reduced but the hogging crack opened, as shown by the deflection profile at 60 min (Figure 12).

Figure 12. Vertical deflections along a north-south strip of the heated ceiling slab

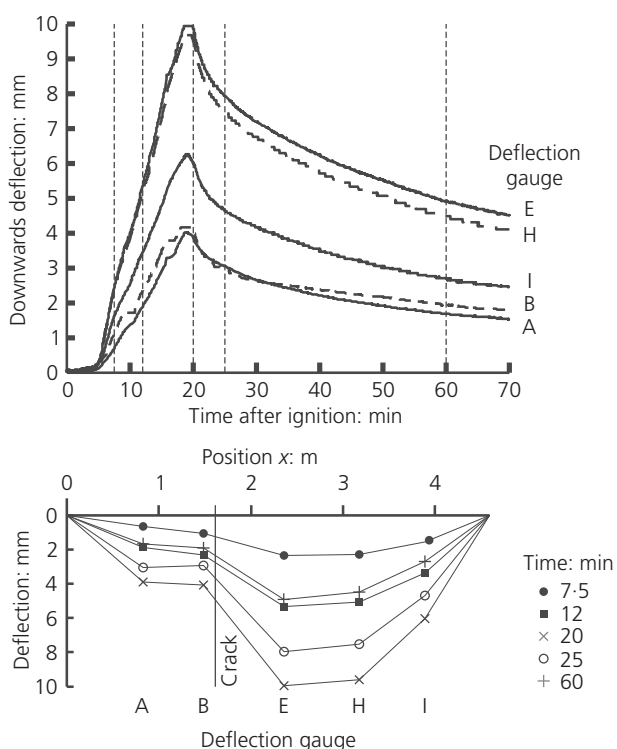
Similar behaviour is seen along the east–west section (Figure 13), where a kink in the deflection profile around gauge B indicates the formation of another hogging crack (Figure 9). As previously noted, the eastern end ($x = 4.6$ m) of the scaffold tube used to support these deflection gauges was not a fixed point on the slab and so may itself have deflected.

Figure 13. Vertical deflections along an east-west strip of the heated ceiling slab

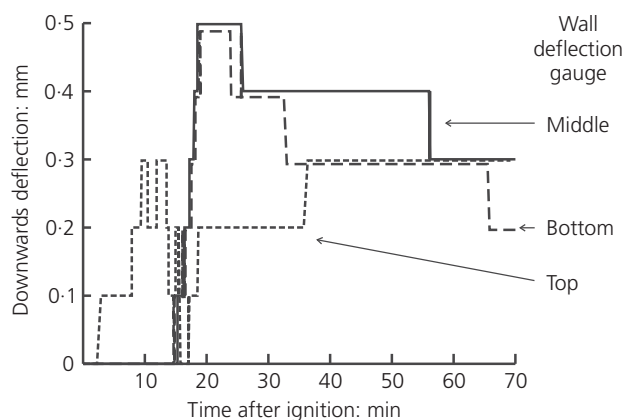
The very small horizontal deflections recorded for the internal wall of the compartment (Figure 14) show that the heating of this wall was small in comparison with that of the compartment ceiling.

Figure 14. Horizontal deflections of the internal structural wall of the fire compartment

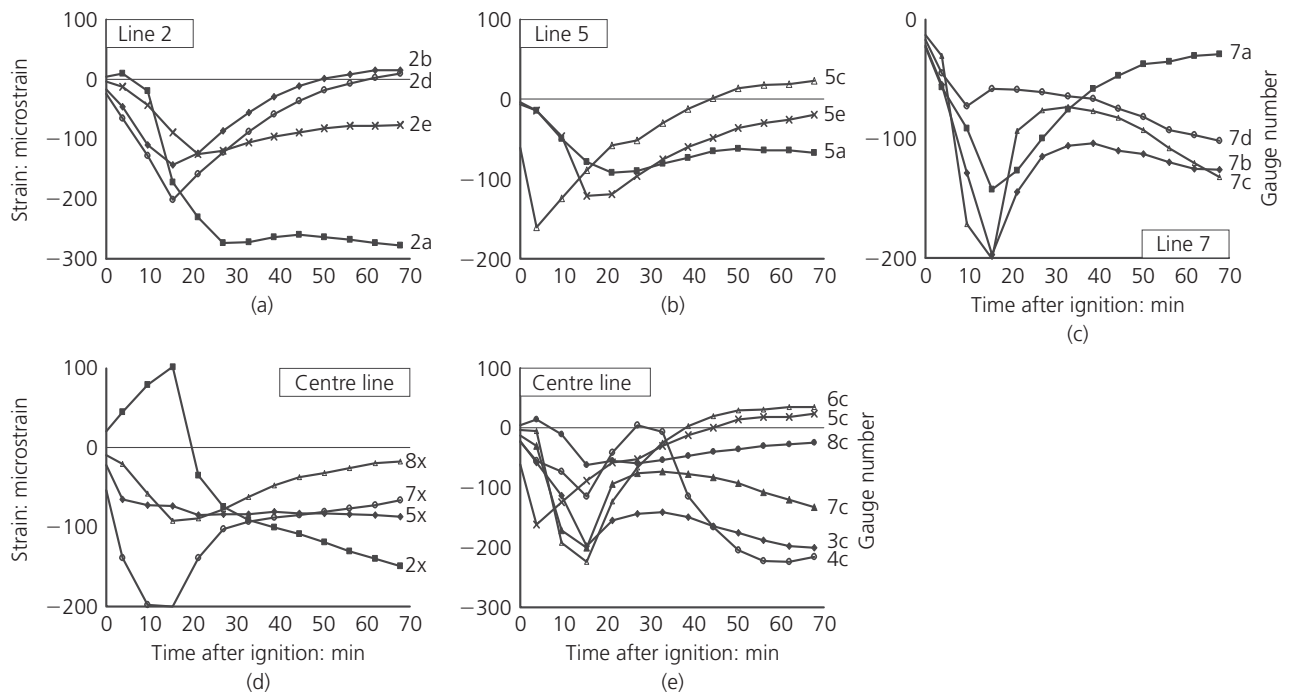
During the heating phase of the fire, the strains measured on the top of the slab increased rapidly. Heat from the fire caused the slab to expand, but it was the concrete in the lower parts of the slab that expanded, not the relatively cool upper surface where the strain gauges were located. The large compressive strains recorded on the top of the slab were dominated by geometrical compatibility with the surrounding structure and due to the internal self-equilibrating stresses created due to the thermal profile through the depth of the slab (Figure 11).

After the fire was extinguished at 19 min, the strains decayed rapidly as the bottom surface of the slab was cooled by water applied by the firefighters. However, the temperature in the upper parts of the slab continued to increase as residual heat conducted upwards (Figure 11). As a consequence, the compressive strains in gauges such as 3c and 7c (see Figure 7) again increased after around 30 min, due to the restrained thermal expansion of the top of the slab.

Figure 15. Strain gauge readings from the upper surface of heated slab at the locations indicated in Figure 7

structure during a realistic fire. In future tests it is recommended that higher resolution strain measurements are made in both time and space so that a full picture is possible of how strain develops within the slab.

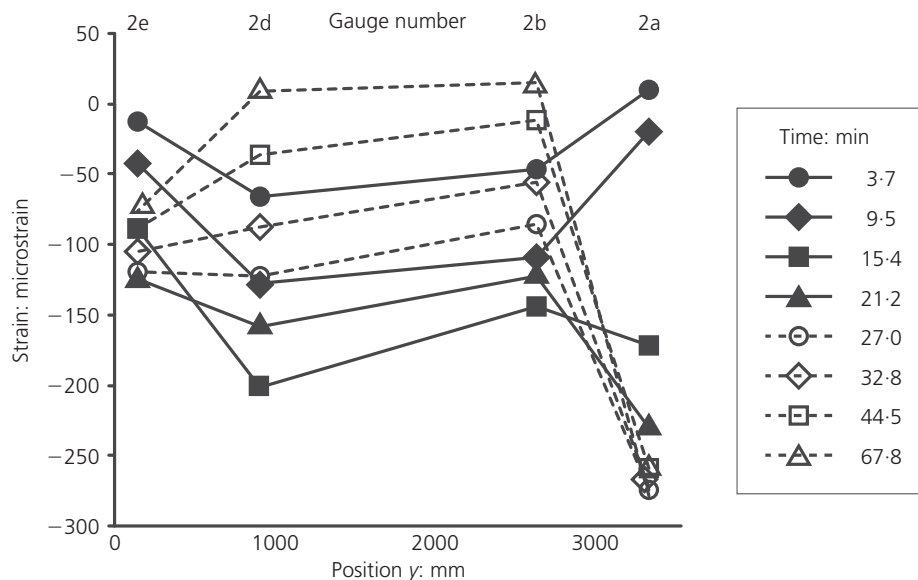
Figure 16 plots the strain profile with position along line 2 at selected time steps. During the heating phase (<19 min), the compressive strains are greater in the centre of the slab, as would be expected in a beam that is heated from underneath and is restrained against rotation and lateral expansion at either end. At 21.2 min (just after the fire was extinguished), there was a sudden jump in strain at gauge 2a and (to a lesser extent) gauge 2e. This

Figure 16. Strain profile with position along line 2 at selected time steps

is believed to be due to the formation of the hogging cracks across line 2 shown in Figure 9, resulting in compression close to the walls as the underside of the slab was cooled. The timing corresponds to the deflection profiles in Figure 12.
